## QUINQUENNIAL INSPECTION REPORT 2021

Location	:Holy Redeemer, Church Hall Upper Church Road, St Leonards on Sea
Parish	: The Parish of the Good Shepard St Leonards-on-Sea

Inspection : July 2021

First Issue 30<sup>th</sup> July 2021

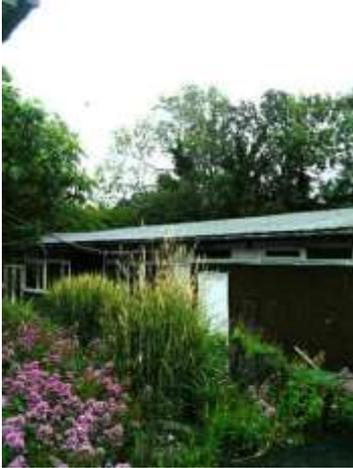
#### 1.1.1 Roof Slope

Roof is covered with felt and is in a reasonable condition but it dips over the hall. The eaves are boxed out in in painted timber and which is starting to peel and will need redecoration probably by the end of this quinquennium. The soffit board may contain asbestos and before any work is done the church should check their asbestos register. Testing may be required to establish exact nature of the material.

C- Up to 5 years:

Modern felt roof with a noticeable dip over the hall, deflection noted in the fascia and soffits. The fascias and soffits will probably need decoration before the end of this quinquennium as the paint is starting to peel.

1.1.1	Painted soffit and barge boards starting to peel and will be in need of decoration this quinquennium	£600
-------	--	------

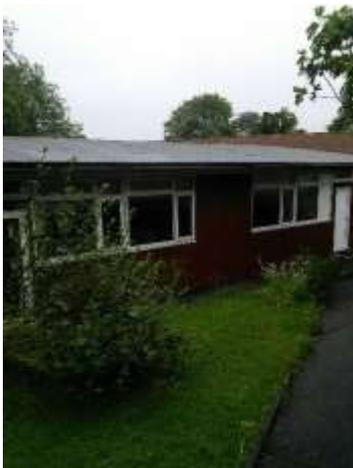
Fair

Plastic rainwater goods, which we presume discharge to soakaways.

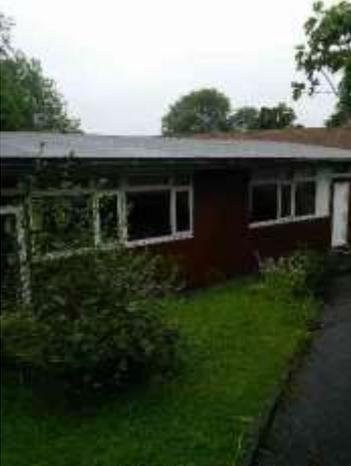
#### 1.3.1 North Wall

Reasonable

Stained timber boarding on brick plinth wall.

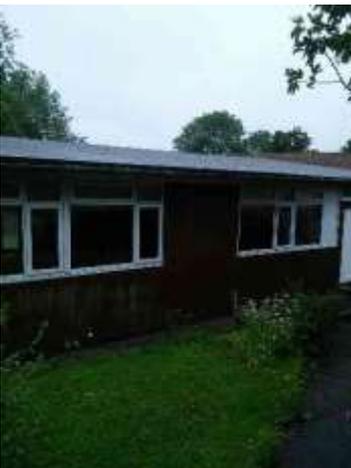
#### 1.4.1 Windows & Doors Generally

Good

Plastic Windows and painted timber doors.

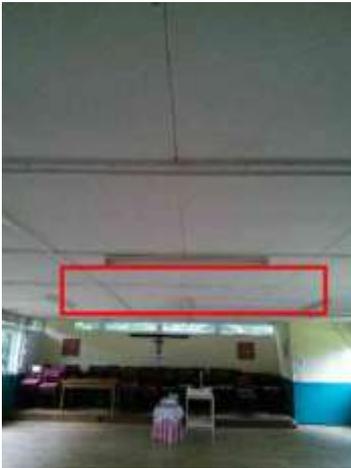
#### 2.1.1 Hall Ceiling

O - Keep under observation

Fair

Hall Ceiling: Paneled ceiling painted, the panels could contain asbestos but more likely they are soft board. If there is not an asbestos survey there needs to be one done. There is some sagging in the trusses towards the dais, which is reflected in roof. We understand the reflection follows replacement of the windows and some strengthening has been carried out but if the deflection continues an engineer may need to advise.

2.1.1	Hall Ceiling: paneled ceiling painted, the panels could contain asbestos but more likely they are soft board. If there is not an asbestos survey there needs to be one done. There is some	
-------	--	--

sagging in the trusses towards the dais, which is reflected in roof. We understand the reflection follows replacement of the windows and some strengthening has been carried out but if the deflection continues an engineer may need to advise.

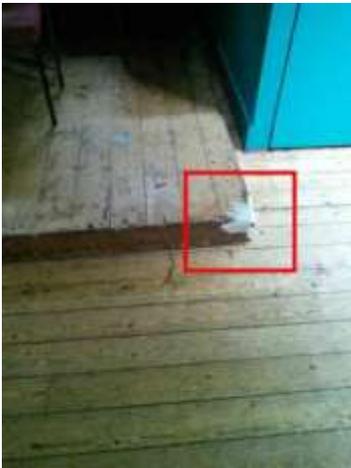
#### 2.2.1 Stage

C - Up to 5 years

Fair

Mobile square sections of wooden dais. Repair needed to broken timber south end.

2.2.1	Mobile square sections of wooden dais. Repair needed to broken timber south end.	£50
-------	--	-----

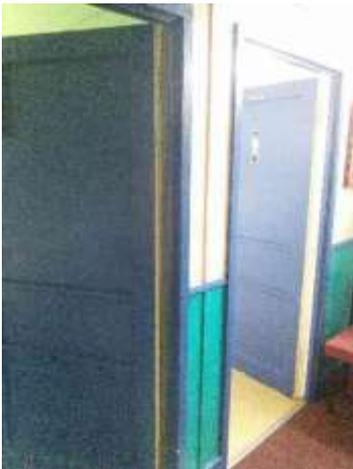
## 2.2.2 Internal Doors

The internal doors are all painted timber doors, and it is noticeable that most of the doors round the hallway need easing as they are catching in their frames. This is suggestive of further movement in the structure and if it continues one must consider if this building is starting to reach the end of its life.

B - Up to 2 years

Needs Repair

Internal Doors: All the internal principle doors off the hall are in need of easing which suggestive of some settlement in the flooring.

2.2.2	Internal Doors: All the internal principle doors off the hall are in need of easing which suggestive of some settlement in the flooring.	£200
-------	--	------

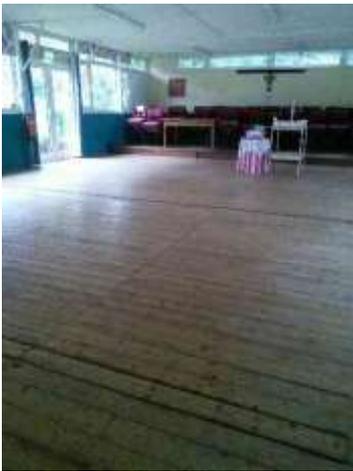
### 2.3.1 Hall Floor

Main hall floor is timber boarded floor which mainly varnishing towards the end of the quinquennium. It rises to the centre of the room suggesting that there has been some settlement in the foundation structure for the building, this does not surprise me as this sort of debris building is normally built with minimal foundations.

Reasonable

Boarded timber floor with slight rise to center suggestive of some foundation settlement. They may need re-varnishing at end of quinquennium or in next.

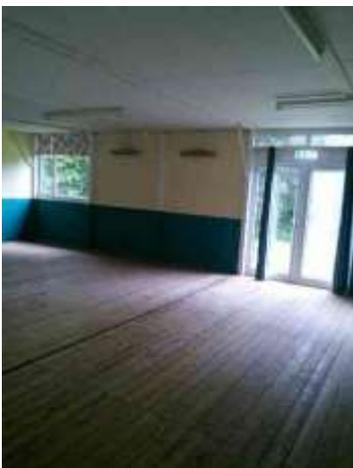
### 2.4.1 Hall Walls

Reasonable

Hall Walls: Painted boarded walls which may contain asbestos or more likely to be soft-board. If there is not an asbestos survey one is needed.

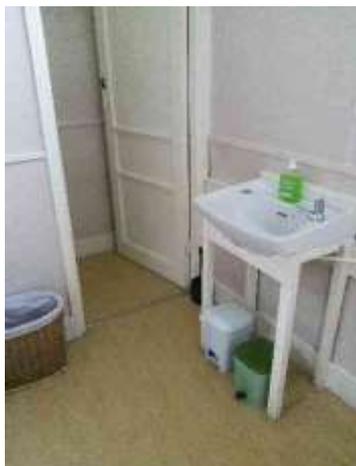
### 2.5.1 Male Toilets

Reasonable

Painted walls and painted softboard ceiling. Suspected Asbestos panel behind two urinals. Sink and toilet cubicle. Sheet vinyl floor. Cold water feed only to basin.

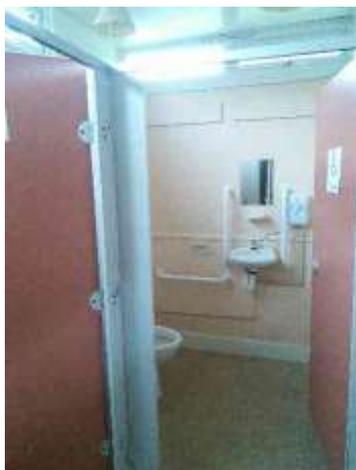
### 2.5.2 Female Toilets And Unisex Disabled WC

D - Desirable Improvements

Reasonable

Female. Toilet: Painted walls and painted softboard. Non slip sheet vinyl floor. Two cubicles with modern cubicles, one with disabled WC, basin water heater and grab rails. Female toilet has basin with cold feed only.

2.5.2	Female. Toilet: Painted walls and painted softboard. Non slip sheet vinyl floor. Two cubicles with modern cubicles, one with disabled WC, basin water heater and grab rails. Female toilet has basin with cold feed only.	£300
-------	---	------

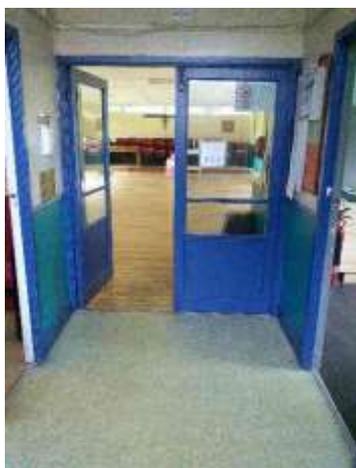
### 2.5.3 Entrance

Reasonable

Painted walls and painted softboard ceiling. Sheet vinyl floor and entrance matt.

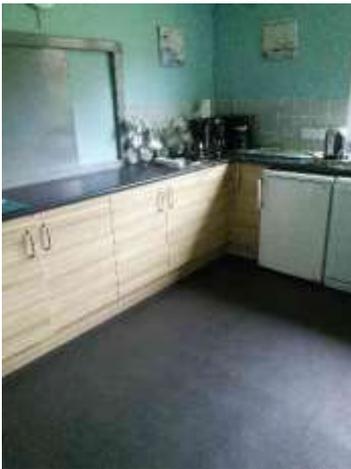
### 2.5.4 Kitchen

There is sheet vinyl in the toilets, kitchen and entrance hall as well as entrance matting. The floor in the kitchen is rucking up which is also suggestive of some fundamental movement in the structure and needs to be adjusted by flooring contractor to prevent a trip hazard.

B - Up to 2 years

Good

Painted walls and painted softboard ceiling, sheet vinyl floor rucking up a little. Tiled splashbacks. Sink, cooker, dishwasher, fridge. Sliding hatch to hall. Electric water heater. Modern kitchen units in good condition..

2.5.4	Painted walls and painted softboard ceiling, sheet vinyl floor rucking up a little. Tiled splash backs. Sink, cooker, dishwasher, fridge. Sliding hatch to hall. Electric water heater. Modern kitchen units .	£60
-------	--	-----

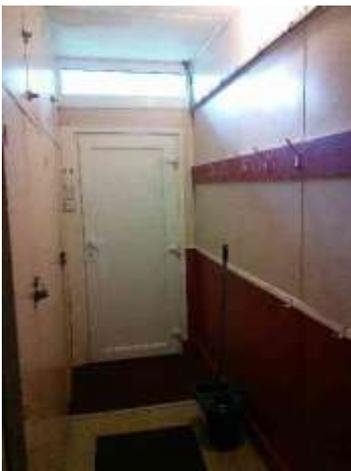
### 2.5.5 Back Corridor

Fair

Painted walls and painted softboard ceiling. Sheet vinyl floor and entrance matt. Coat hooks on wall and set of locked cupboards.

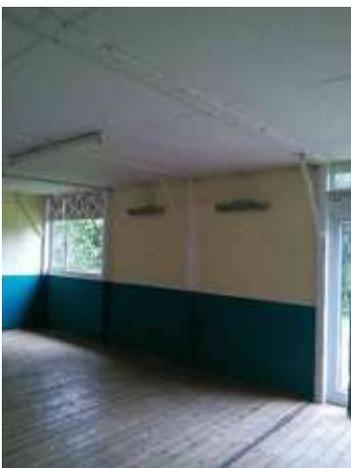
### 3.1.0 Heating

There is a basic heating system using overhead radiant electric heaters in the hall, and wall mounted in the toilets. Ideally this heating system would be upgraded but considering the age of this very lightweight structure the Finance Committee may decide it's not worth the expenditure.

Poor

Heating: the hall is minimal with a few wall mounted electric heaters in hall and one in the kitchen. There are a couple of small electrical tube heaters in toilets.

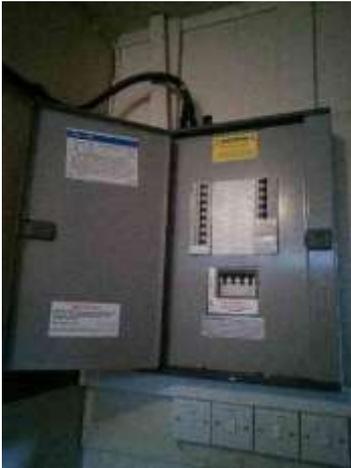
#### 3.2.1 Electrical Testing

C - Up to 5 years

Routine Maintenance

The electrical periodic test has recently been done and next due 20/11/25

3.2.1	The electrical periodic test has recently been done and next due 20/11/25	£200
-------	---	------

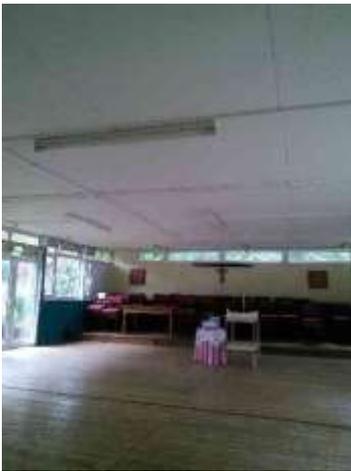
#### 3.2.2 Lighting

Reasonable

Fuorescent lights in hall and illuminated emergency exit signs.

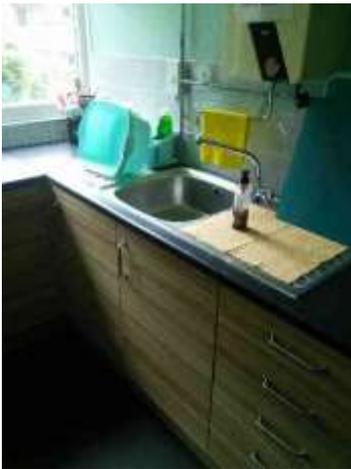
### 3.4.0 Water supply

Good

Mains water supply present.

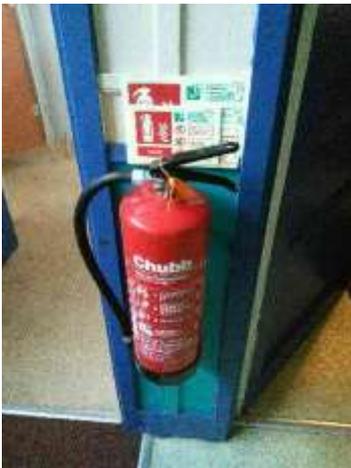
#### 3.5.1 Fire protection (1)

M - Routine Maintenance

Needs Maintenance

Fire extinguished in entrance, kitchen and hall, hand bell in hall, fire blanket in kitchen Services in 2020

3.5.1	fire extinguished in entrance, kitchen and hall, hand bell in hall, fire blanket in kitchen Services in 2020	
-------	--	--
